# Henry Dickens Court Estate

## Windows/Door – Low Level Blocks

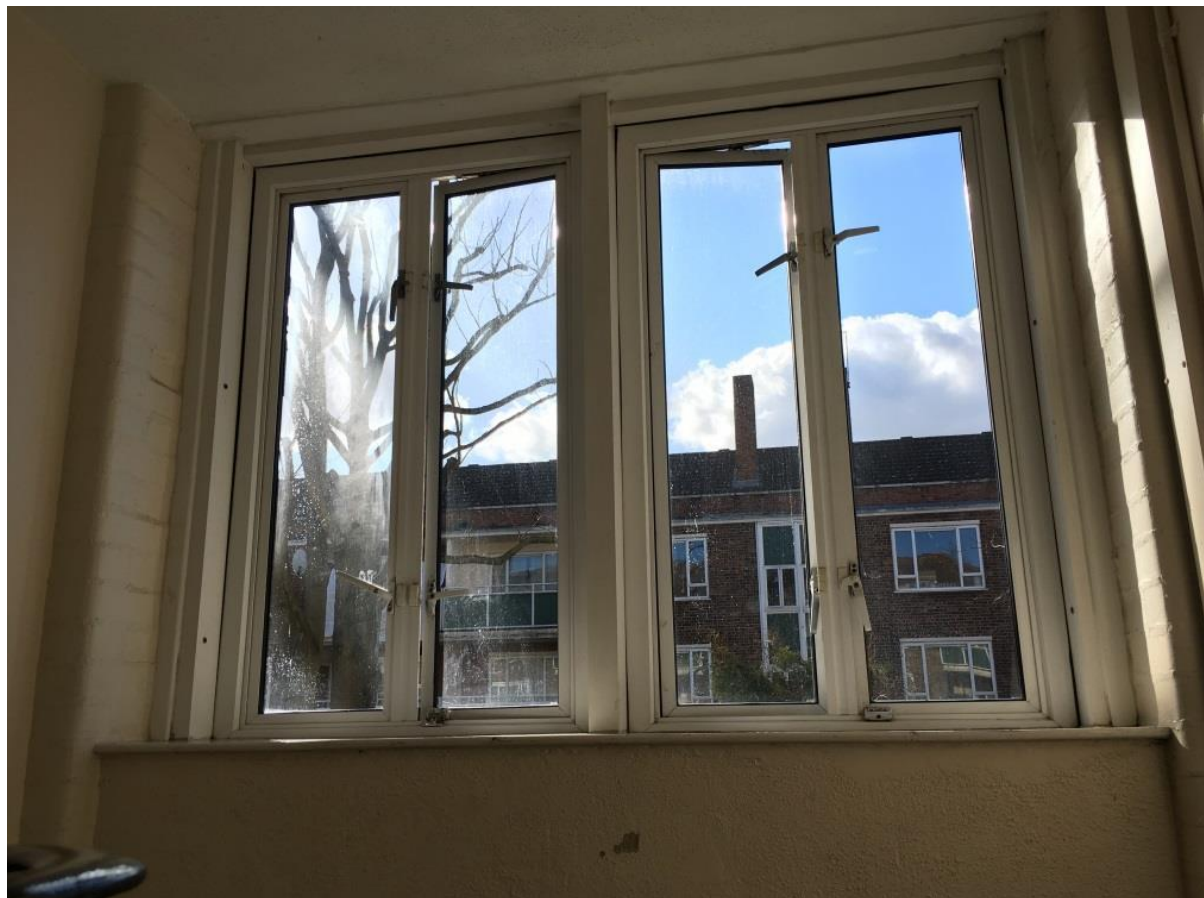
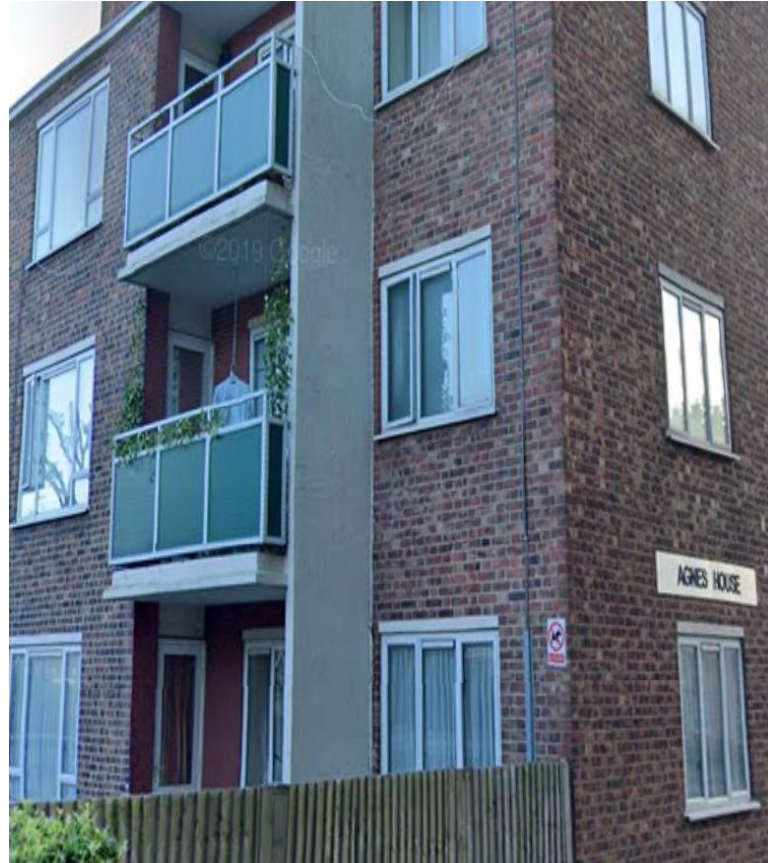
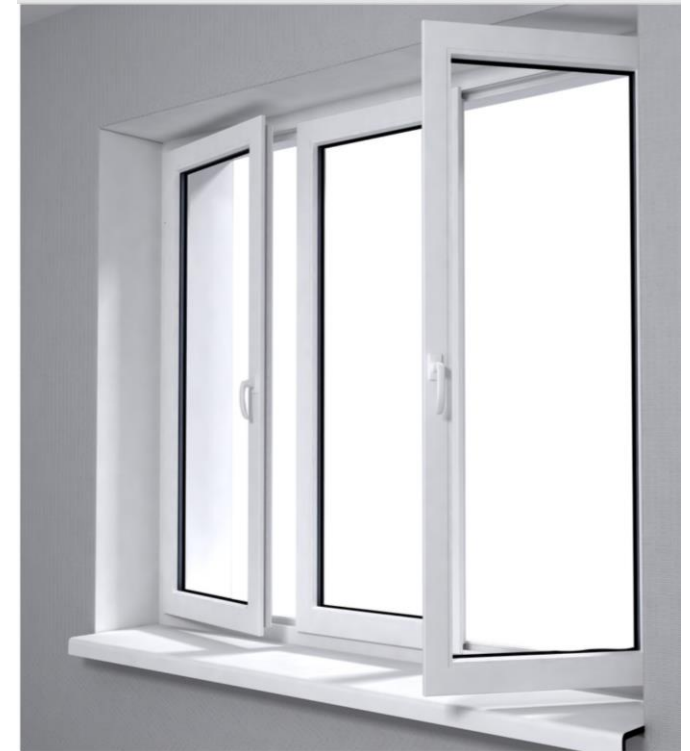
## Current

- Single Glazed Aluminium
- 25-30 years old
- Inefficient

## Proposed

- Double Glazed uPVC
- Increased thermal efficiency
- Longer life
- Durability

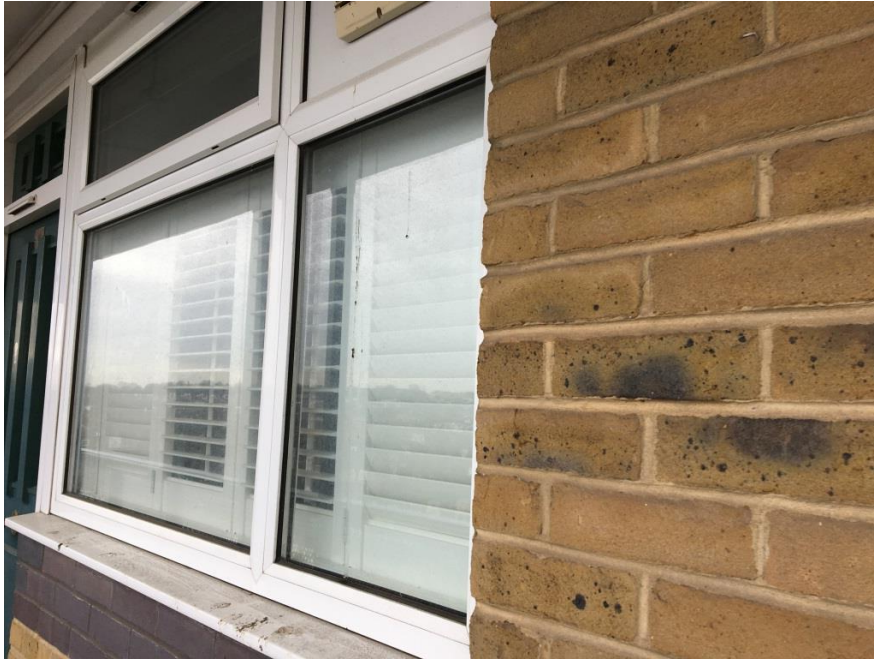
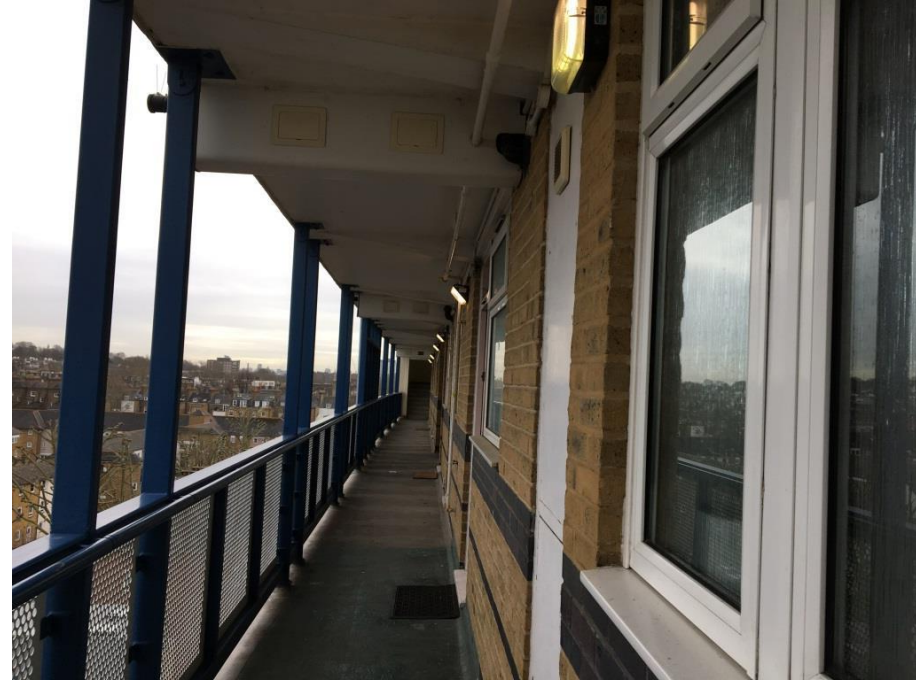
# Carton House & Marley House

1. Currently – Double Glazed uPVC
2. Proposed – Repair
3. Condition – 7/10 year life expectancy
4. Proposed consultation with all residents of both blocks to bring forward replacement
5. Whole life cost analysis undertaken Repair v Replacement

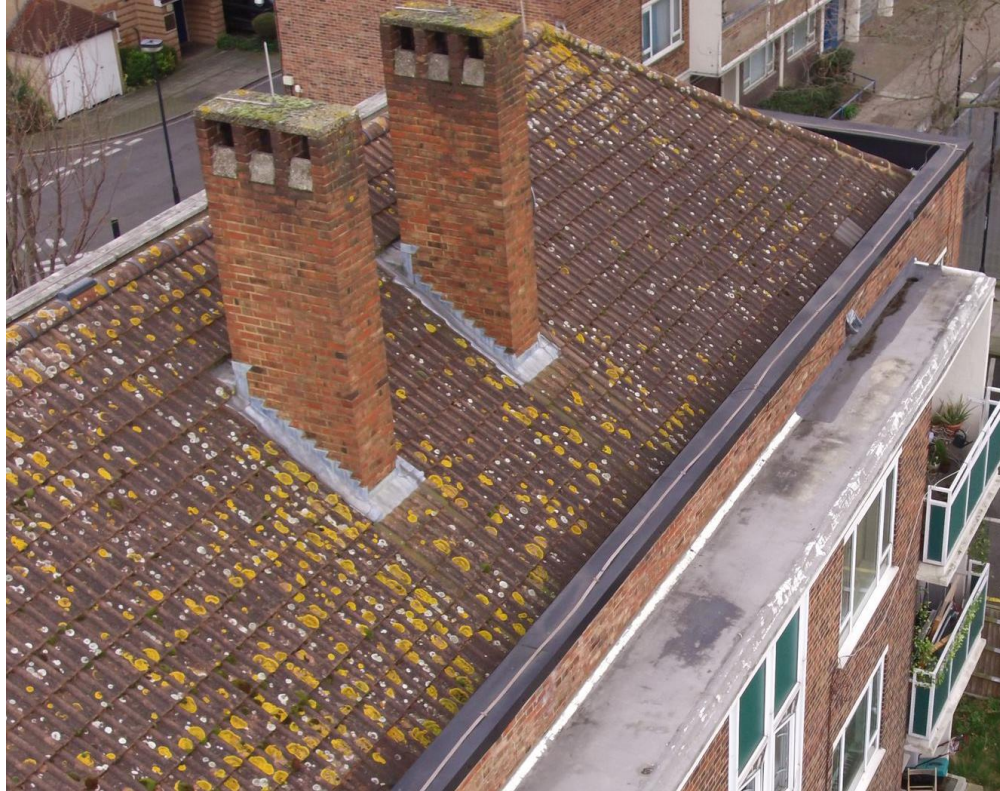
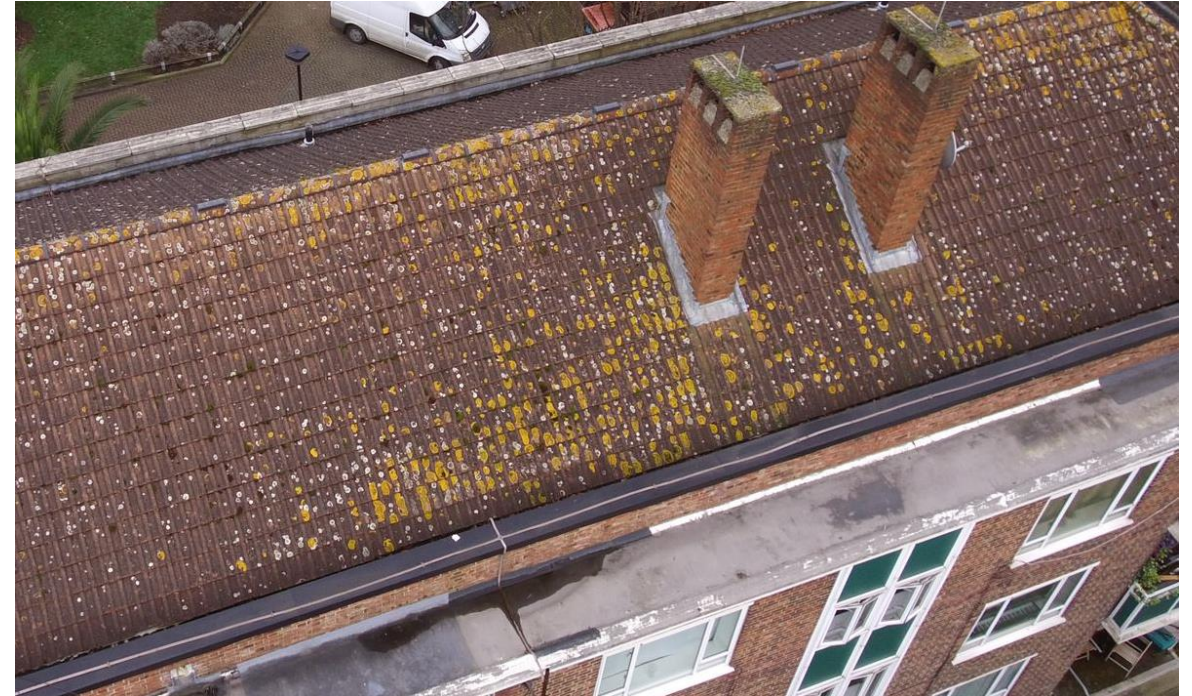
# Roofs – All Blocks

- Proposed – Repair – good overall condition
- Clean/ remove moss
- Repair Parapets, Rain Water Goods, Gutters, Flashings, Chimneys,
