**Fire Engineering Analysis Report**  
**TRG-220089-RT-01-FE-104**

**Project**  
**Lancaster West Sitewide**  
**Fire Service Access and Facilities**

**Date of Issue**  
**24-Jan-23**

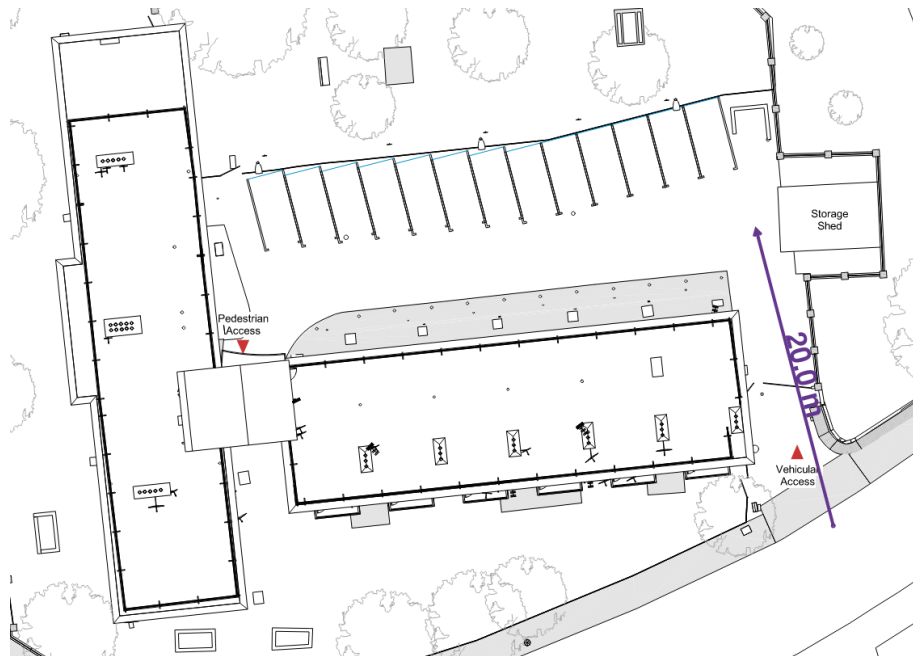
Figure 4.1 – Fire service route to Treadgold House

- 4.3.5 Where dead-end access routes are longer than 20m, the recommendations of ADB would expect suitable turning facilities to be provided. Fire vehicle access up to the main entrance of the building is provided via the car park. Access to within 18m of the main entrance of the building requires vehicle access down a dead-end route that exceeds 20m. Whether suitable turning facilities are available in the car park is to be confirmed, however, it is deemed unlikely based on the space shown available on plan.

- 4.4.1 Access to the building is provided at ground floor level, with access to the stair core available from the car park to the rear (pedestrian entrance to the building illustrated in the figure below).
- 4.4.2 The gated entrance to the car park has a fob entry system including an intercom and a firefighting override switch.

- 4.3.4 Based on the guidance set out in ADB, if the design for Treadgold House was submitted for Building Regulation approval today, it is likely that the provision of a dry riser would be recommended to satisfy the functional requirements. It is therefore recommended that in the event that significant works are carried out at the block, consideration should be given to installing a dry riser(s).

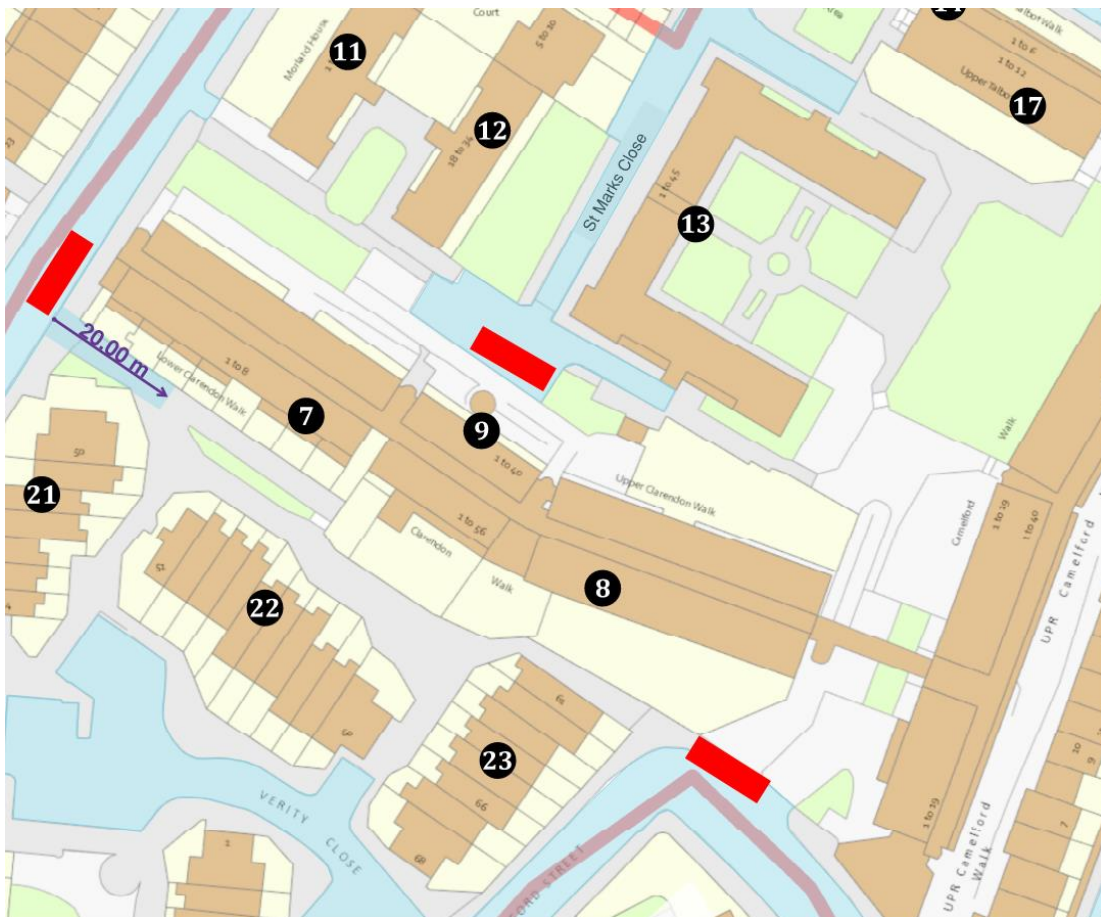
Figure 6.1 – Fire vehicle access to Clarendon Walk

6.3.4 The expected hardstanding locations for the fire vehicle on approach to Clarendon Walk have been shown red in the figure above. The furthest point in the furthest flat has been measured to be up to 85m, along the route of the hose from the expected fire vehicle location.

- 
- 6.3.5 Based on the guidance set out in ADB, if the design for this building was submitted for Building Regulation approval today, it is likely that the provision of a dry riser would be recommended within each stair with fire vehicle access provided within 18m of each inlet valve to satisfy the functional requirements. It is therefore recommended that a dry riser is provided in each stair core as part of the proposed works for Clarendon Walk.
- 6.3.6 Where dead-end access routes are longer than 20m, the recommendations of ADB would expect suitable turning facilities to be provided.
- 6.3.7 Vehicle access to Clarendon Walk is considered restricted. Travel distances to the entrance of at least one of the stair cores, measured from the fire vehicles expected hardstanding location, have been measured to exceed 18m.

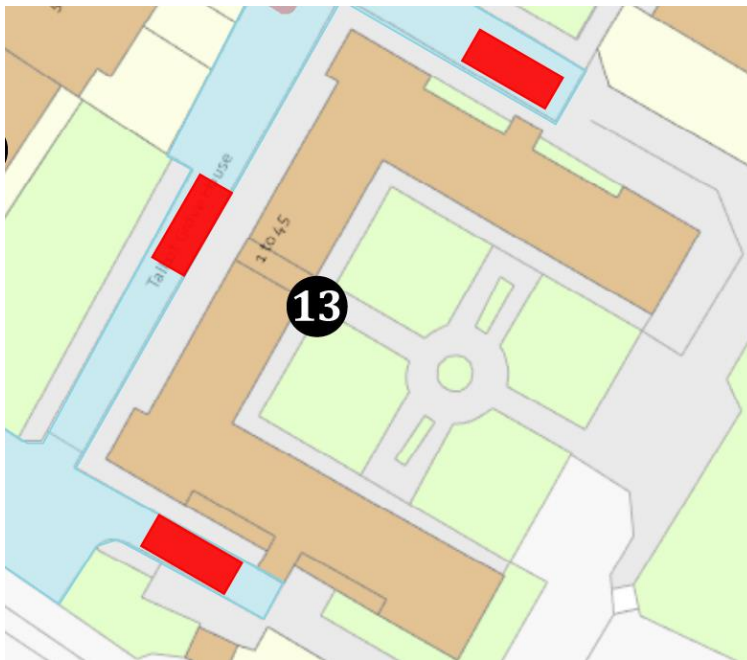
Figure 9.2 – Fire vehicle access to Talbot Grove House

- 9.3.1 In accordance with ADB where dry risers are not provided, access for a pumping appliance should be provided within 45m of all points inside each flat, measured along the route of the hose.
- 9.3.2 The expected fire vehicle hardstanding locations to each stair core have been shown red in the figure below, via St Marks Close (the private Fire Brigade access road). The furthest point in the furthest flat has been measured to be up to 50m from the expected fire vehicle location.

- 9.3.3 Based on the guidance set out in ADB, if the design for Talbot Grove House was submitted for Building Regulation approval today, it is likely that the provision of dry risers within each stair core would be recommended to satisfy the functional requirements. It is therefore recommended that in the event that significant works are carried out at the block, consideration should be given to installing a dry riser.
- 9.3.4 Access to Talbot Grove House provides adequate turning facilities for fire vehicles.

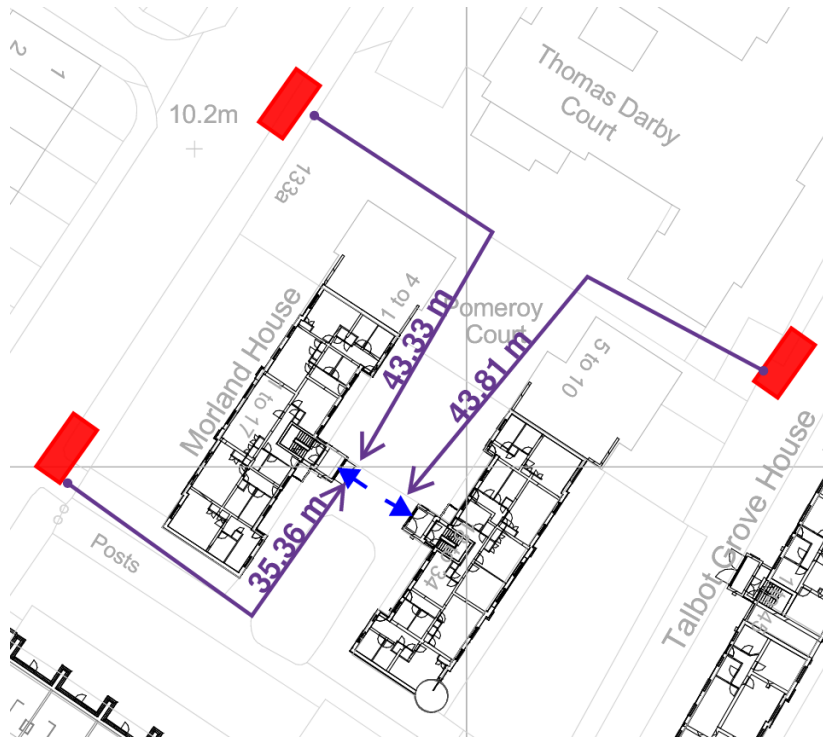
Figure 10.1 – Fire vehicle access to Morland House

- 10.3.1 In accordance with ADB where dry risers are not provided, access for a pumping appliance should be provided within 45m of all points inside each flat, measured along the route of the hose.
- 10.3.2 Access to each stair is from the central courtyard.
- 10.3.3 The expected fire vehicle hardstanding locations to each stair core have been shown red in the figure below. Distances from the hard standing locations and the entrance into each block have also been shown in the figure below.

- 10.3.4 The furthest point in the furthest flat is measured up to 75m from the expected fire vehicle location.
- 10.3.5 Based on the guidance set out in ADB, if the design for Morland House was submitted for Building Regulation approval today, it is likely that the provision of dry risers within each stair core would be recommended to satisfy the functional requirements.
- 10.3.6 Access to Morland House provides adequate turning facilities for fire vehicles.

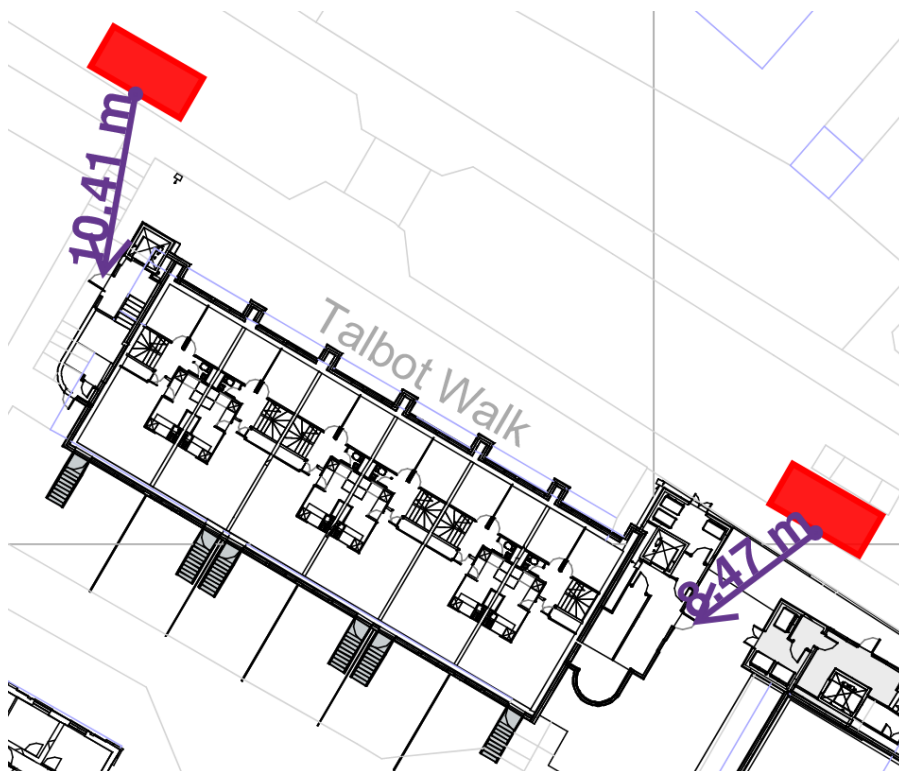
Figure 11.1 – Fire vehicle access to Talbot Walk

- 11.3.4 The furthest point in the furthest flat has been measured to be up to 79m from the expected fire vehicle location.
- 11.3.5 Based on the guidance set out in ADB, if the design for Talbot Walk was submitted for Building Regulation approval today, it is likely that the provision of a dry riser would be recommended to satisfy the functional requirements. It is therefore recommended that in

the event that significant works are carried out at the block, consideration should be given to installing a dry riser(s).

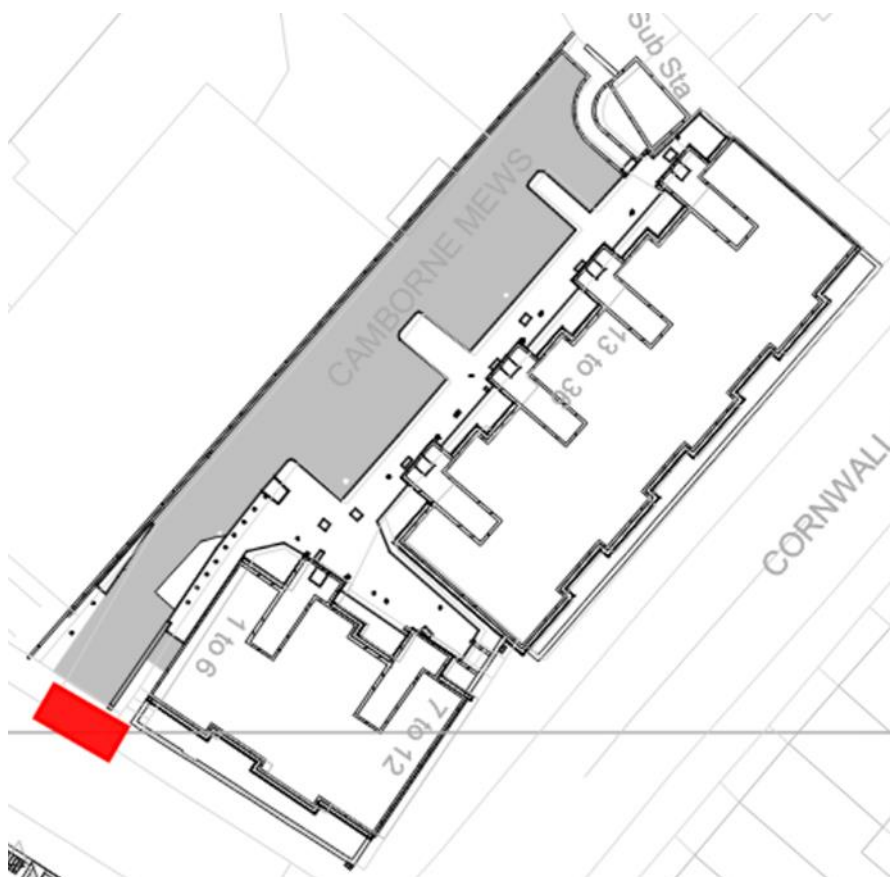
Figure 12.1 – Fire vehicle access to Camborne Mews

- 12.4.1 Access to each block is provided from the gated car park. However the car park is not considered a fire service access road as it does not meet the recommendations below.

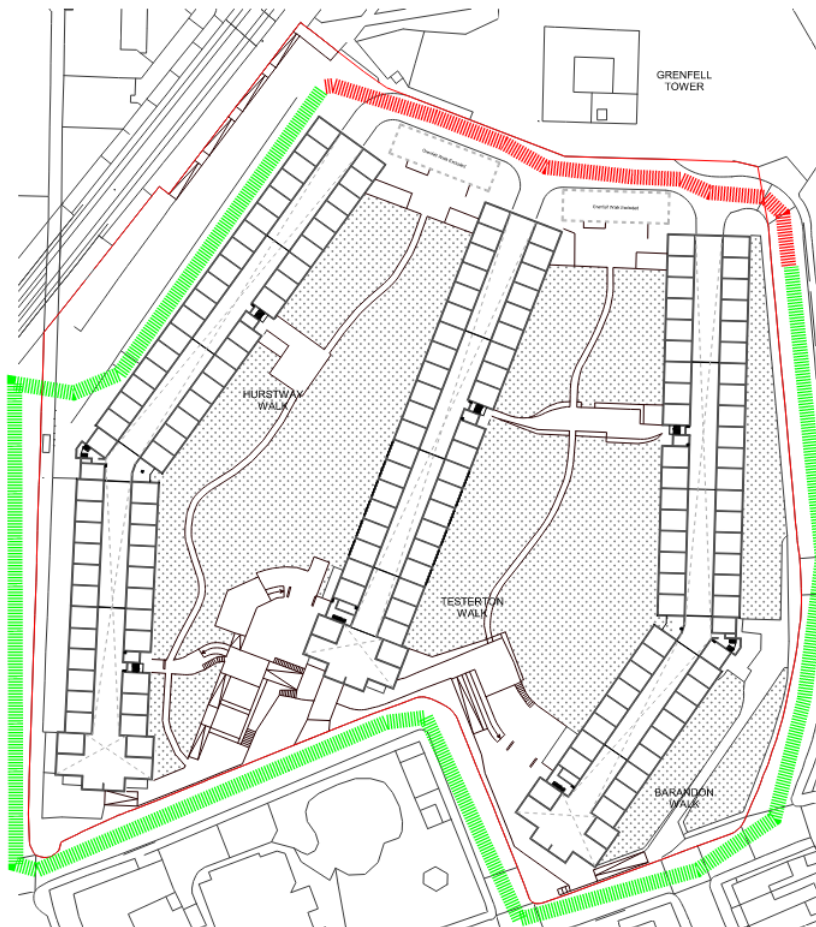
Figure 13.1 – Fire vehicle access to the walkways

13.3.2 The furthest point in the furthest flat has been measured to be up to 80m, along the route of the hose from the expected fire vehicle location.

13.3.3 Based on the guidance set out in ADB, if the design for the Walkways was submitted for Building Regulation approval today, it is likely that the provision of a dry riser would be recommended to satisfy the functional requirements. It is therefore recommended that a dry riser is provided in each stair core as part of the proposed works for Camelford Walk.

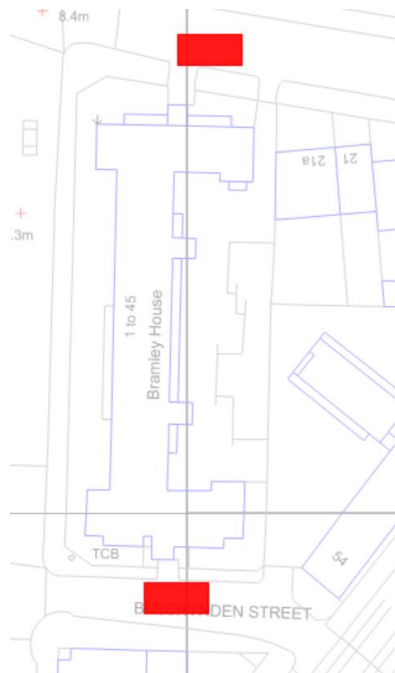
*Figure 14.2 – Fire vehicle access to Bramley House*

14.3.3 Access to Cores 02 and 04 is available from the gated courtyard/car park.

14.3.5 Fire vehicle access is available to the roads around the building (Bramley Road, Blechynden Street and Silchester Road) but not to within 18m of all stairs as there is not currently vehicular access to the courtyard at the rear of the building.

14.3.4 Based on the guidance set out in ADB, if the design for Bramley House was submitted for Building Regulation approval today, it is likely that the provision of dry risers within each stair core would be recommended to satisfy the functional requirements. It is therefore recommended that in the event that significant works are carried out at the block, consideration should be given to installing dry risers.
