LANCASTER WEST LOT 4 - TREADGOLD HOUSE

0003-ECD-XX-XX-RP-A-03003-P05

EMERGING PREFERENCES & CHOICES REPORT

OCTOBER 2021

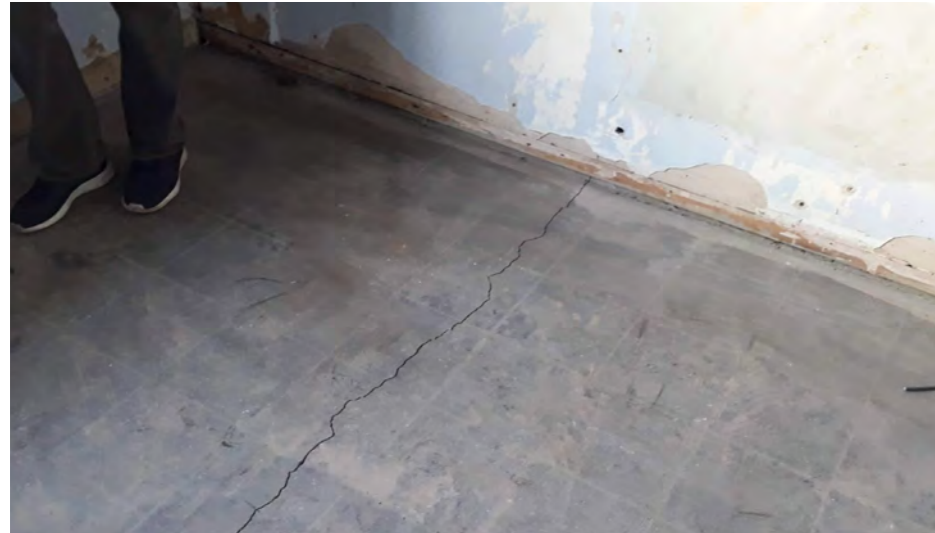
Figure 11 - cracking to floor screed, overhang maisonette floor

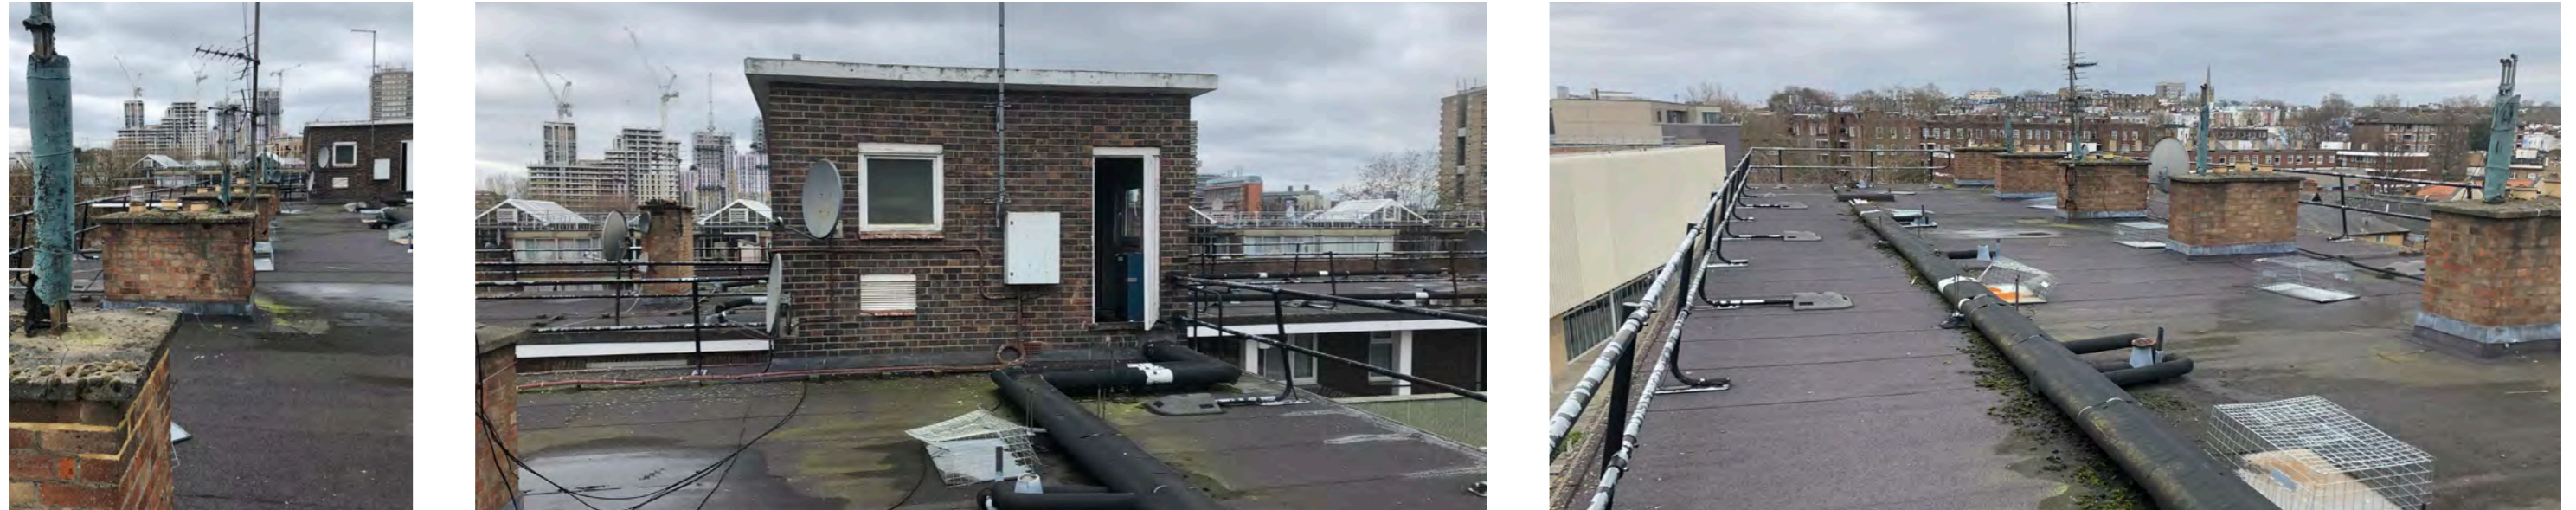
The Eastern side of the roof presents six chimney breasts and is easier to access. The roof covering appears to be in poor condition, with significant ponding and soft areas. There are several TV aerials installed and animal cages which will require removal. The roof doesn't have an appropriate parapet but a free-standing guard rail which has been installed around the perimeter.

Figure 19 - East wing roof conditions

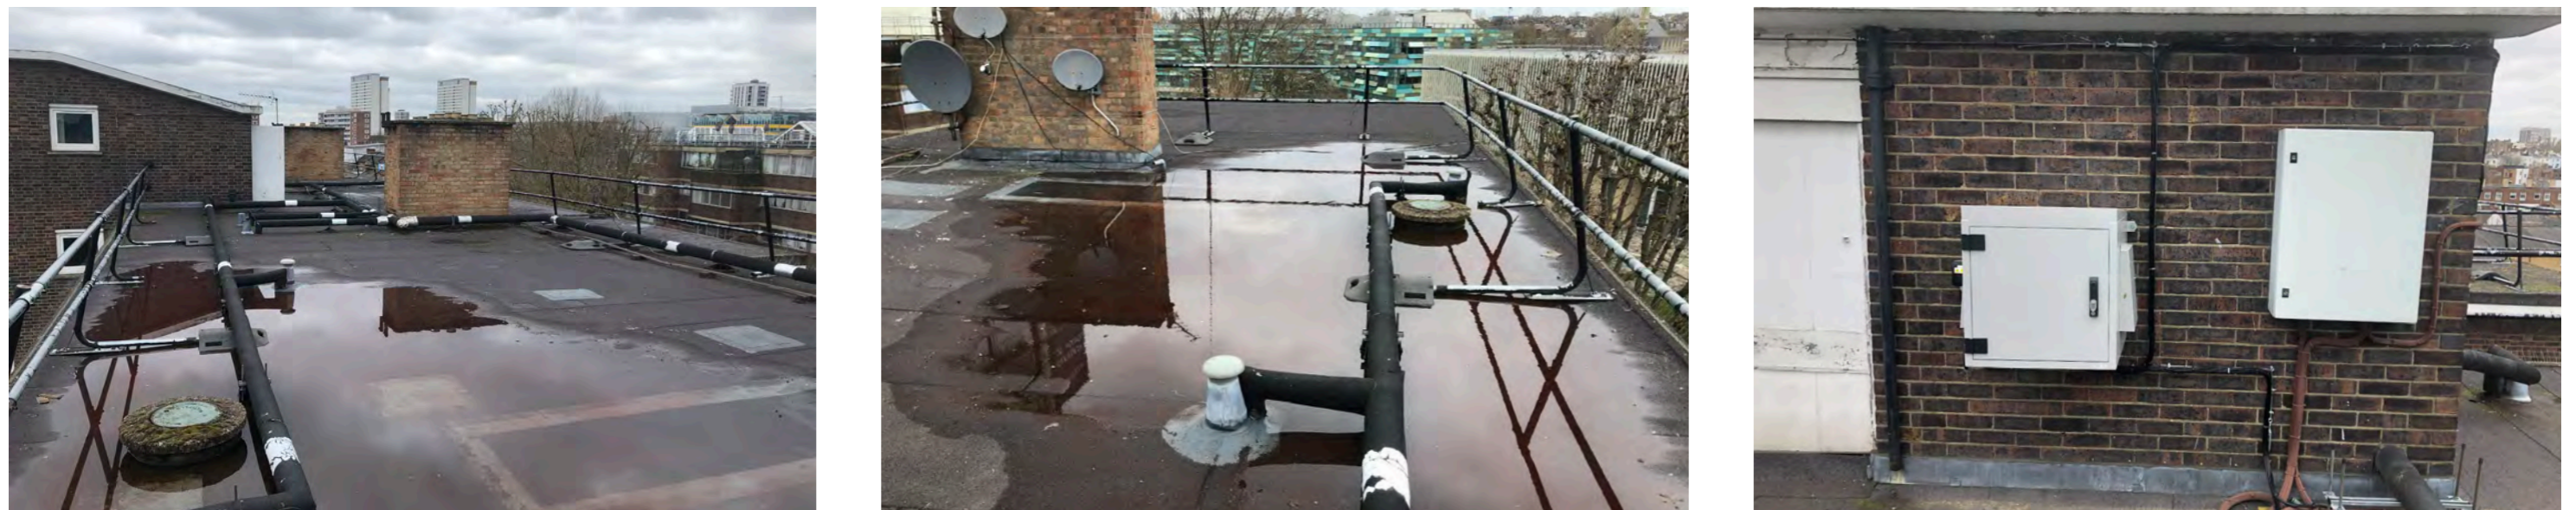
The Western side of the roof includes three chimney breasts and it is more difficult to access than the Eastern side. The access is through the water tank room which is flooded and requires large steps over existing pipework. There is at present a large water leak in the room, which probably comes from the pipework rather than from one of the two tanks. There is significant ponding on the roof, particularly around the north end. The guard rails enclose the perimeter but they stop 4-5m short of the northern edge. There are also several aerials that will require removal. New fibre optic cabling runs on the external wall of the water tank room.

Figure 20 - West wing roof conditions

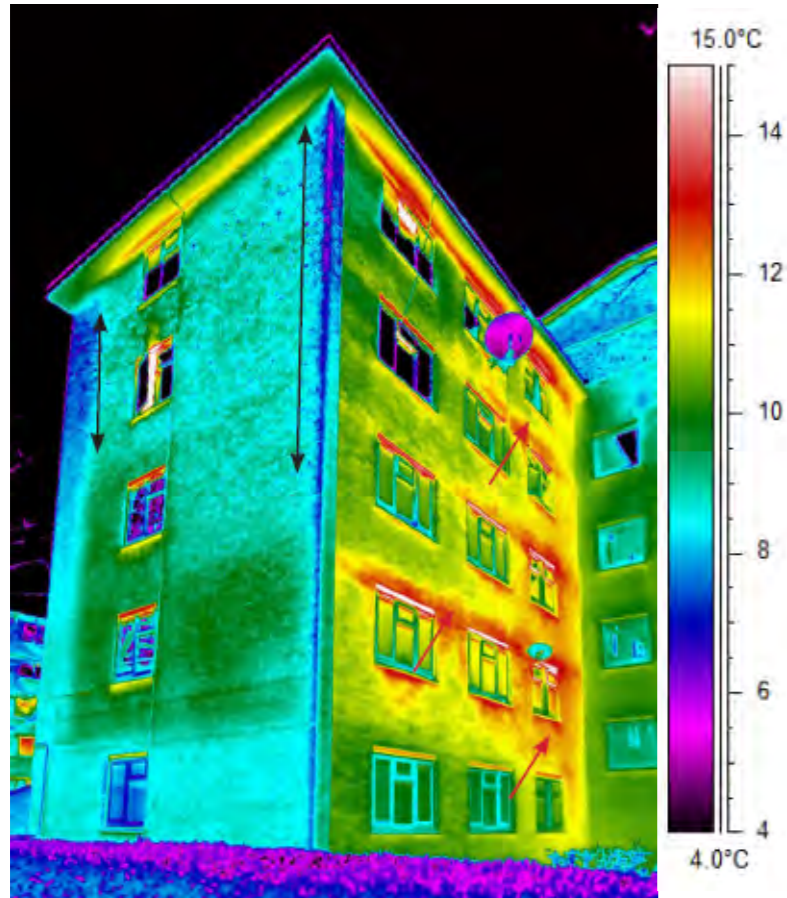
Figure 21 - Wall to the south of the staircore. Red areas above windows show heat is being lost here, presumably through metal lintels that bridge the wall. Larger patches of red above and below windows suggest that the wall is wet here. Cavity insulation may be damp. Drip marks below some of these windows suggest that there may be a problem with drainage from above here. The contractor will need to carry out further investigations to establish the cause of this water marking, and allow to make it good.

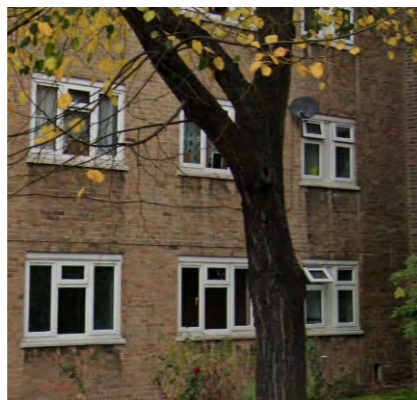
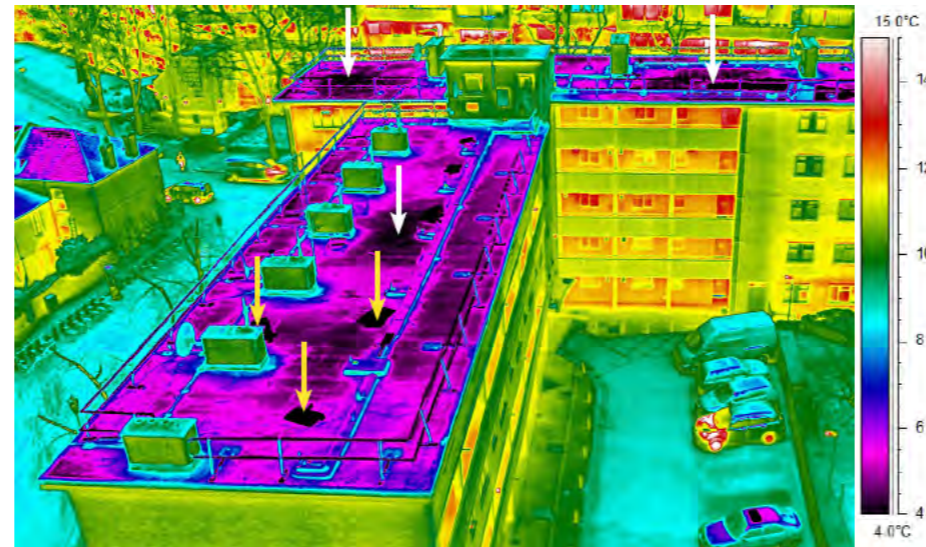
Figure 22 - Roof, with white arrows indicating areas of standing water and yellow arrows indicated discarded items on roof. The roof appears to have a relatively even heat loss, suggesting consistent performance across it. The low temperature recorded on the roof means that little heat was being lost through it. This is consistent with the roof condition report that showed that the insulation was generally dry and consistently applied.

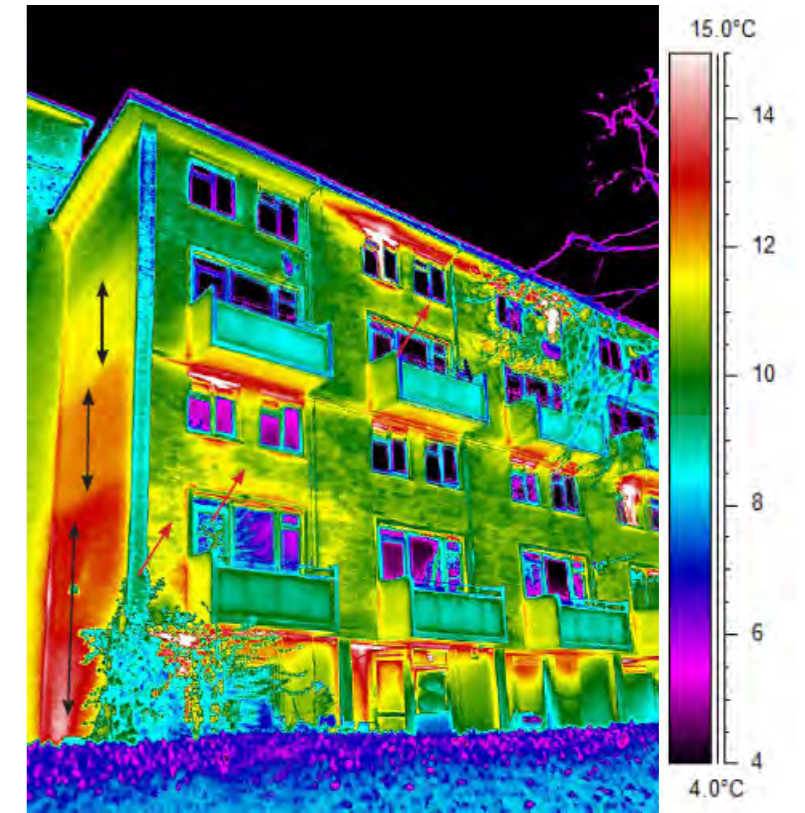
Figure 23 - South facade of the east wing. It is clear that heat is being lost where the balcony floors meet the building as these areas appear red. There is also a lot of heat loss from the ground floor studio screens, suggesting that there is little or no insulation here.
