# LANCASTER WEST'S FIRST LOW-ENERGY HOME

## VERITY CLOSE RETROFIT JOURNEY

ECD ARCHITECTS

LANCASTER WEST  
NEIGHBOURHOOD TEAM

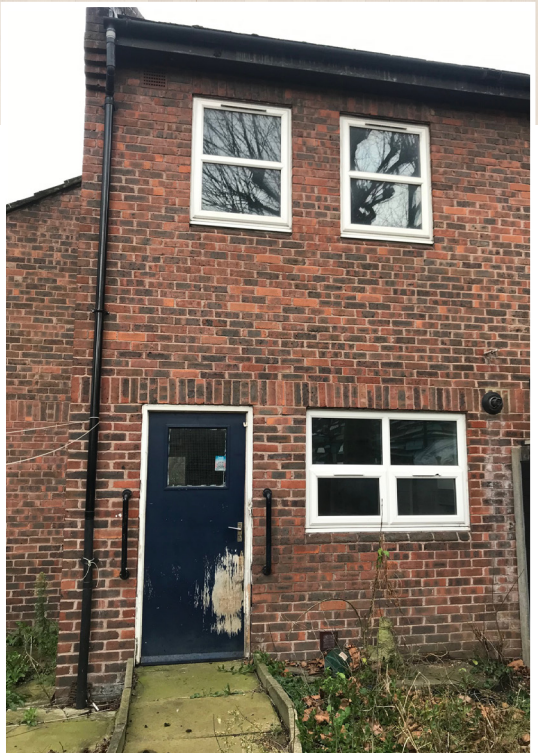
Figure 7 - The home at Verity Close prior to retrofit

It is a 3 bedroom end of terrace, cavity wall property, with some existing cavity wall insulation.

Original windows had previously been replaced with double glazed units, and there was some existing loft insulation. However a solid uninsulated concrete floor, original vent openings in walls, poor window installation and the lack of a continuous line of insulation meant that the house was not very energy efficient.

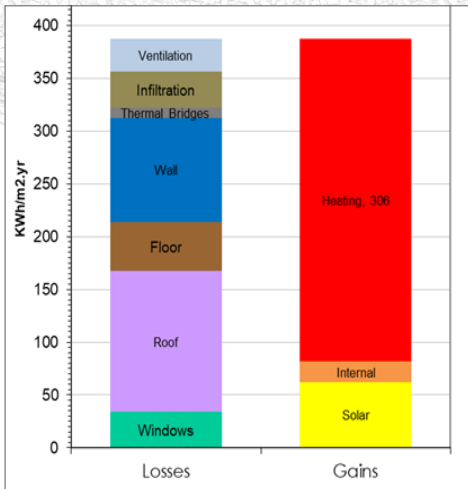
Figure 8 - Heat losses & gains prior to retrofit

This sets out how the existing building was losing heat and a range of methods for reducing heat loss. Each of these was explained in terms of spatial implications, pros and cons and energy bill reduction.

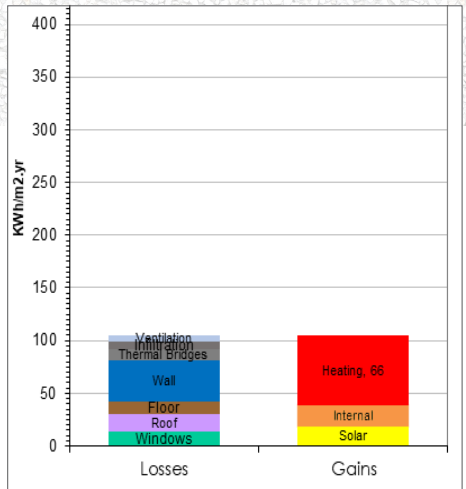
Figure 9 - Predicted heat losses & gains after retrofit

This showed that space heating demand could be reduced from around 300 kWh/m<sup>2</sup>/year to 66 kWh/m<sup>2</sup>/year.

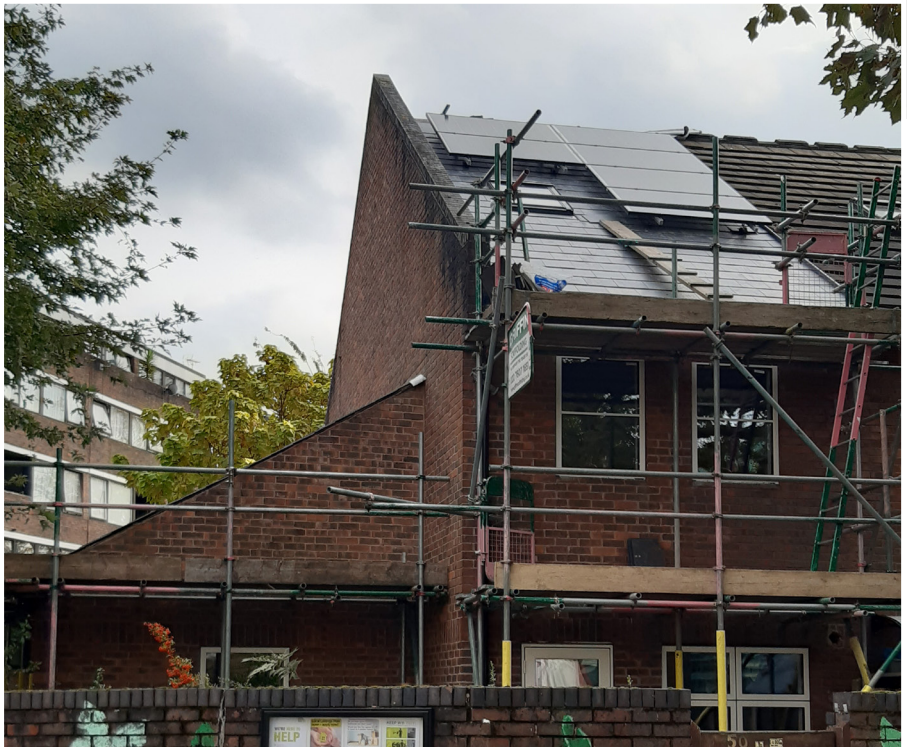
Figure 12 - The home as roof works were completed

Key to achieving this reduction in heating demand was creating a continuous line of insulation and of airtightness. The existing house's construction made this challenging

in some areas, as did the need to insulate walls internally. Ecological Building Systems advised ECD on appropriate non-combustible, breathable insulation systems and airtightness products. Together with triple glazed windows, doors and rooflights these achieved the most continuous line of insulation and airtightness possible.

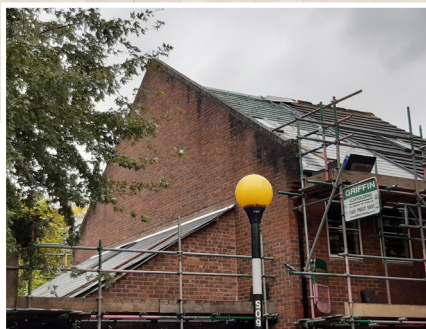
Figure 13 - During works to the roof

LWNT wanted to replace the roof covering to ensure longevity, and together with the poor quality of the existing roof structure, this led to the decision to replace the roof almost entirely. The new roof is insulated with mineral wool and has an airtightness membrane to the inside of this, taped and sealed to the airtight plaster on the walls.

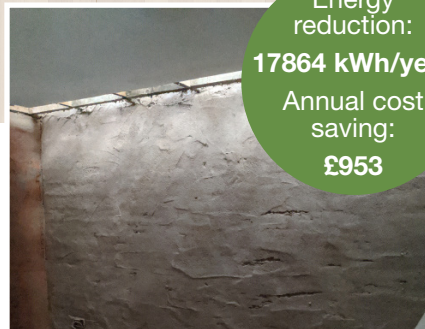
Figure 14 - Walls with internal insulation freshly applied

External walls were covered in Diathonite plaster. This is a breathable, airtight, insulating plaster made of lime, cork, clay and reinforcing fibres.

A thick layer to the inside of external walls, as well as a thinner covering to the party walls reduced heat loss through the walls by more than half. This was applied between floor joists to ensuring a continuous covering, reducing the possibility of cold spots and gaps in the building's airtightness.

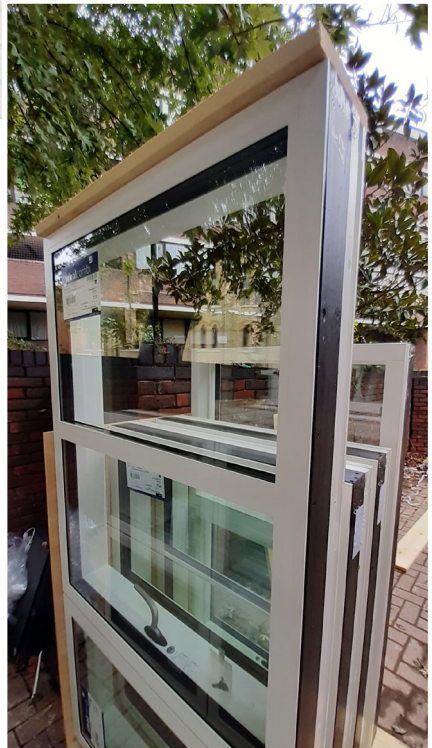
Figure 16 - New windows being delivered to site

The existing windows were double glazed, but had been poorly installed, with visible gaps when opening panes were supposedly closed. This led to warmed air escaping from the home both at the junction of the window with the wall and around the opening panes of the windows.

The existing window frames were not very insulating, so heat was also lost by conduction through these. This all led to draughts and cold spots around windows.

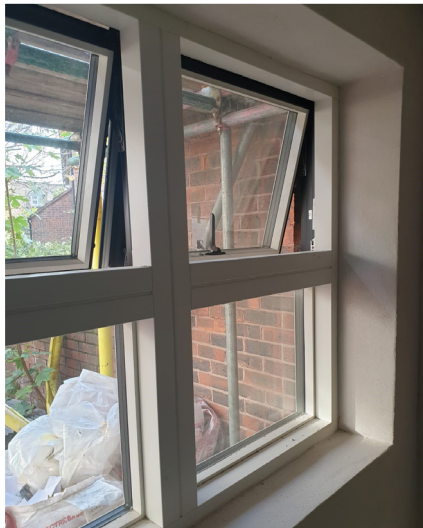
Figure 17 - New windows, designed to open similarly to existing windows

Triple glazed windows with airtight seals have been used throughout, and are designed to replicate the appearance of the existing windows, with openings in the

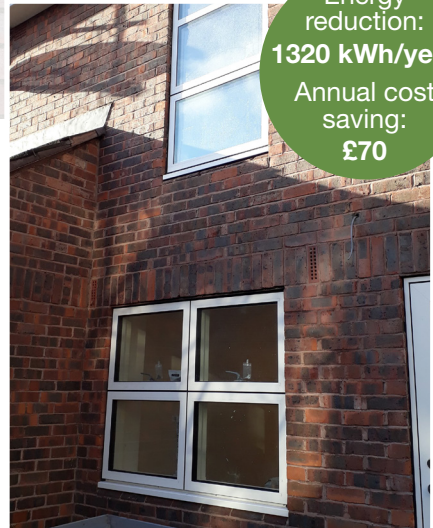
Figure 18 - Window frames are airtight and better insulated but still appear relatively 'light' externally

same locations and similarly narrow frames. The wall insulation has been sealed to airtightness tape around the window frame, ensuring air no longer escapes at this junction.

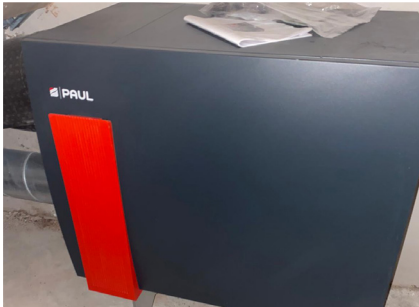
Figure 21 - MVHR unit in roof space

The mechanical ventilation with heat recovery unit has been installed in the attic space, with a pull down ladder into the attic allowing occasional access for filters to be changed. Fire rated ductwork carries the air around the home, and it comes out through supply terminals in the ceilings.

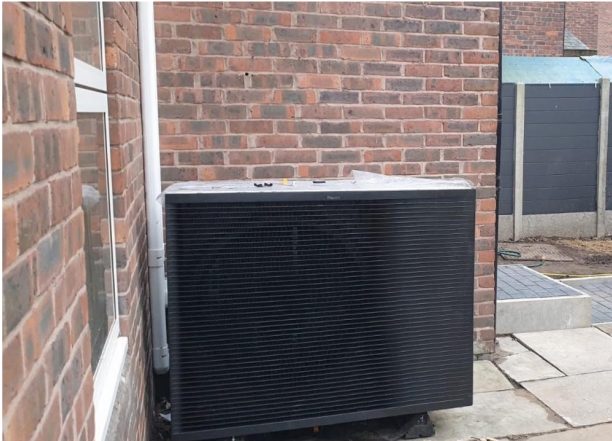
Figure 22 - Air source heat pump external unit

The main ASHP unit sits in the garden and refrigerant carries the heat energy to the inside of the home where it warms the water. This water is then used as hot water in the home for showers, baths, washing up etc, as well as being distributed to the radiators in the usual way.

There is heat energy in cold, outdoor air. An Air Source Heat Pump (ASHP) takes this small amount of heat energy from lots of air and concentrates it, and transfers the energy to water, heating it up. This hot water is then used to heat your home and provide you with hot water from the taps. For every unit of electrical

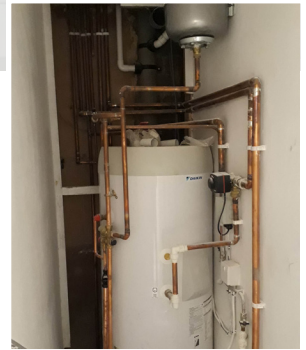
Figure 23 - Hot water tank & pipework in under-stairs cupboard

A hot water tank in a ground floor cupboard ensures that there is a sufficient supply of hot water for the residents to use.

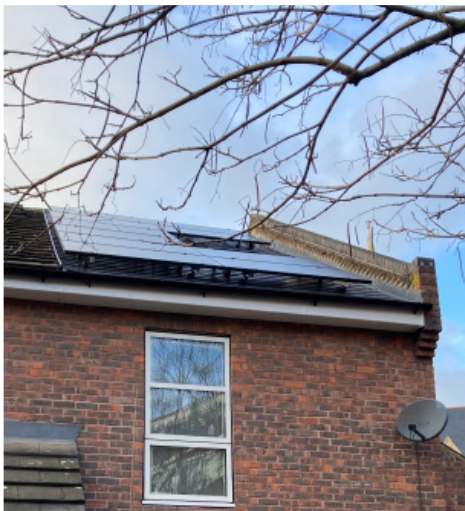
Figure 24 - Photovoltaic panels to the east side of the roof

Photovoltaic panels have been installed on the roof of the building to collect energy from sunlight and turn it into electrical energy for use in the home.

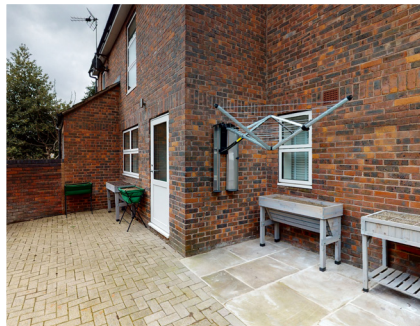
Figure 26 - Rear garden with washing line & planters

A washing line has been included to encourage clothes to be dried without resorting to the use of a tumble drier, which uses a lot of energy. Electric car charging is also catered for with a car charging point next to the parking space.

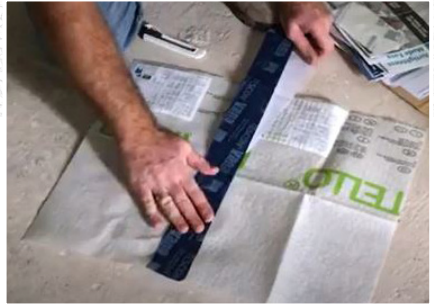
Figure 29 - Practicing airtightness taping on a small scale

carried out a 'toolbox' talk on site, conveying the importance of airtightness and practicing using the paint, tapes and membranes needed to achieve this. Specialist installers were used to apply the wall insulation and install the MVHR and its ductwork.

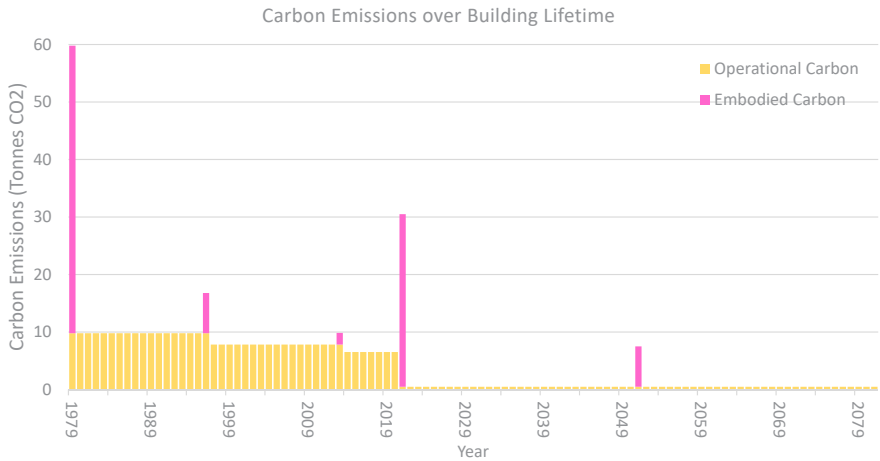
Figure 31 - Carbon emissions over the building's lifetime, from start on site to 60 years post-retrofit

The retrofit has further added to the home's embodied carbon, as a lot of new materials have been added into the house, and some old ones disposed of. It has also led to a huge reduction in the home's carbon emissions in operation, so overall it will reduce the home's whole life carbon emissions over the rest of its life.
