LANCASTER WEST LOT 4 - TREADGOLD HOUSE

0003-ECD-XX-XX-RP-A-03003-P05

EMERGING PREFERENCES & CHOICES REPORT

OCTOBER 2021

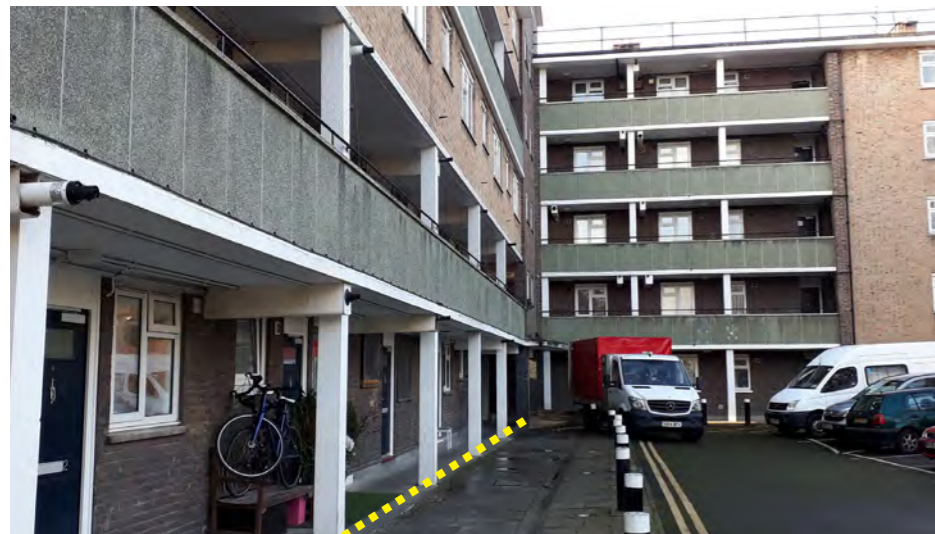
Figure 12 - Assumed Concrete foundation edge line (view from the car park)

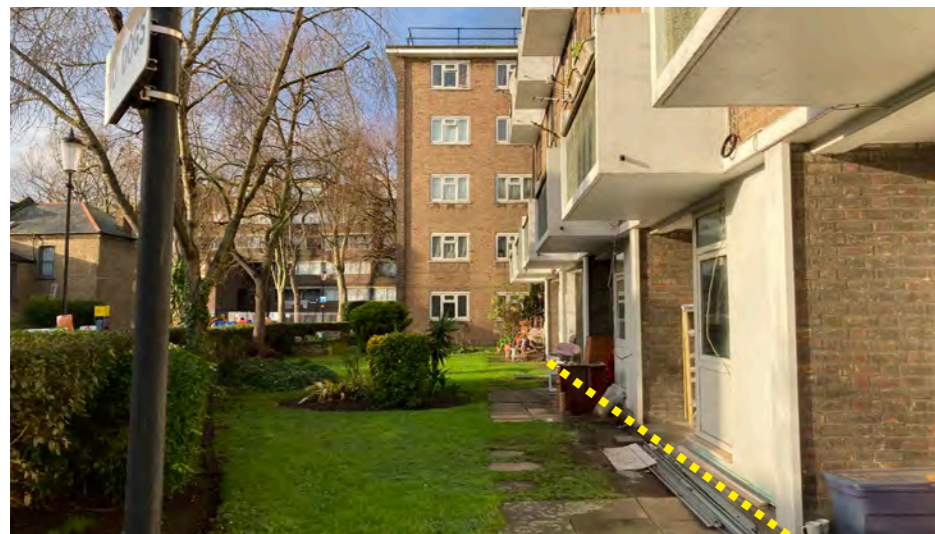
Figure 13 - Assumed Concrete foundation edge line (view from the main gate)

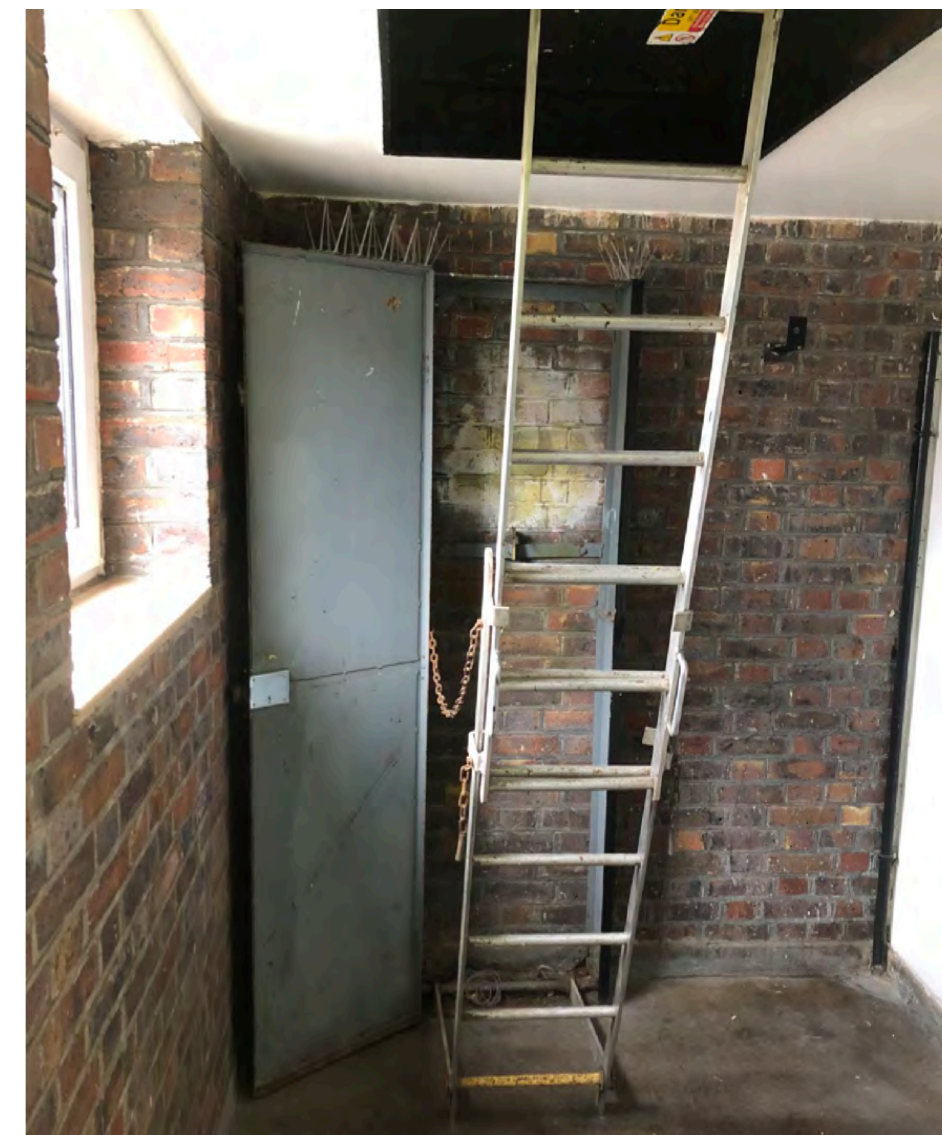
The only access to the roof is from a ladder on the 4th floor. The ladder is kept within the adjacent cupboard but it is very old and requires replacement. The two access hatch doors are heavy and narrow and they require fixing into place. Once through the hatch there are handholds to facilitate the access. The landing itself is hazardous until the hatch doors are closed as you need to walk across the opening to access the roofs. Moving to the roof, the narrow access doors require a large step over the threshold.

Figure 16 - Access to the roof from the third floor

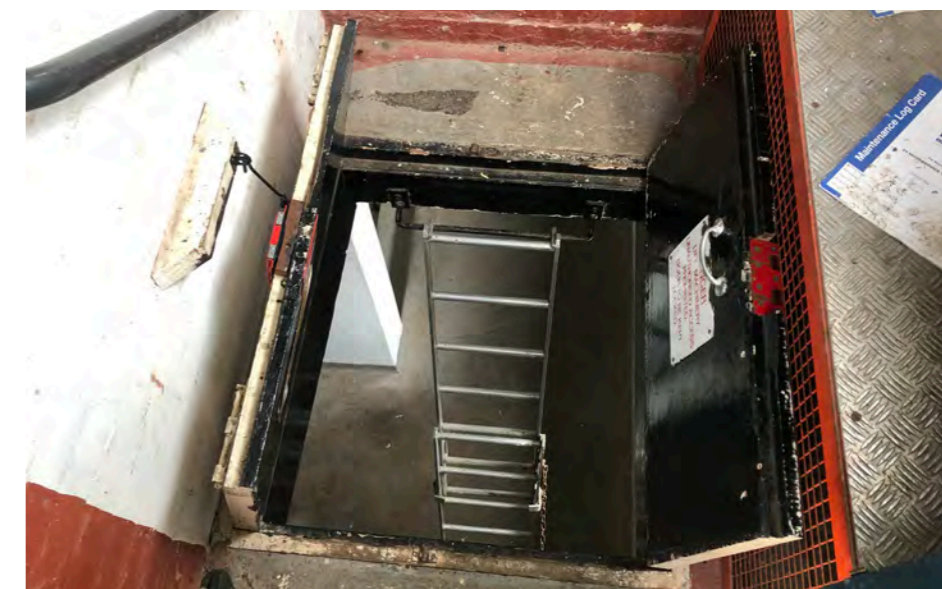
Figure 17 - Access to the roof from above

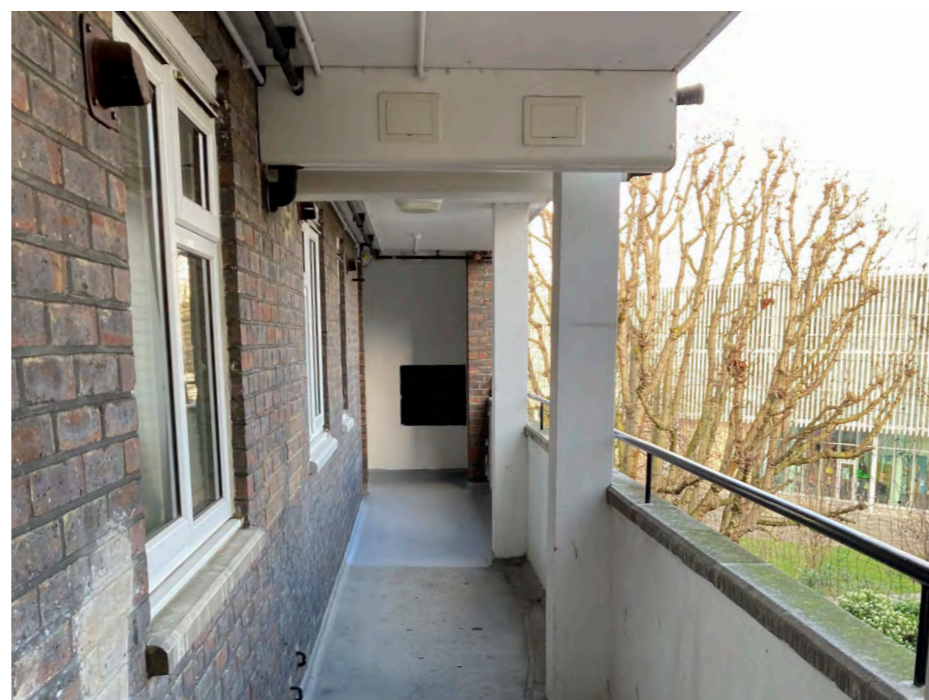
The homes were originally heated by fireplaces, and chimney breast, chimney stacks and original coal hatches remain. It is assumed that chimneys have largely been closed up, though this may not be the case in all leasehold flats. The homes are now heated by gas boilers. These burn gas to heat hot water, which is then provided to taps and to radiators which heat the homes. Boiler flues run across the soffit of the access decks.

Figure 31 - Boiler flues to soffit of deck access

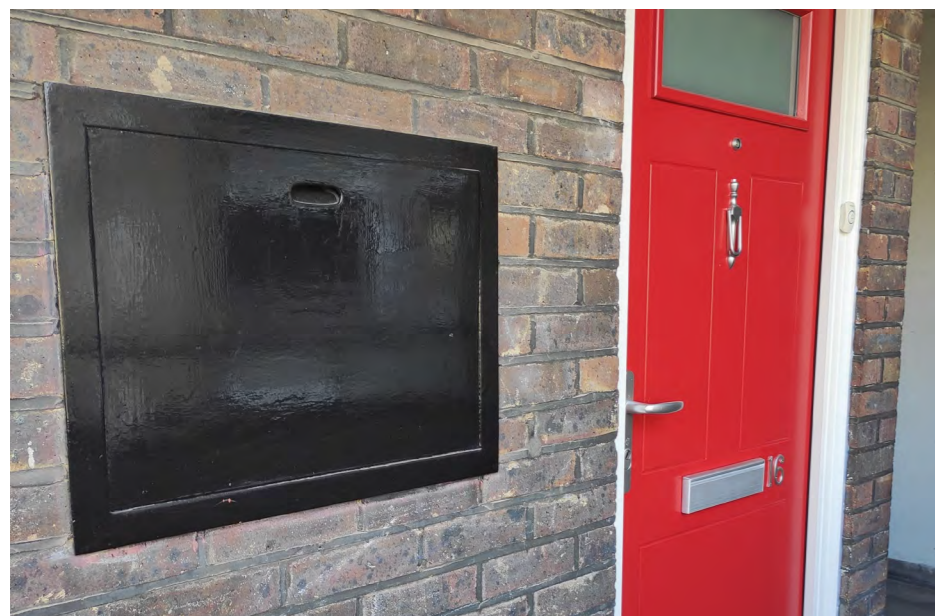
Figure 35 - Coal chute door

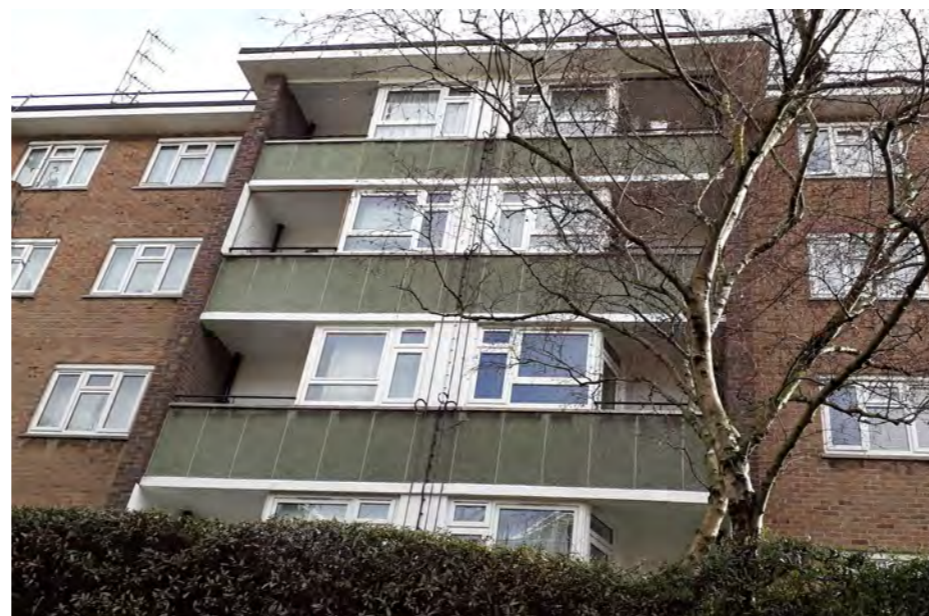
Figure 32 - Rainwater pipes run down rear corner of inset balconies

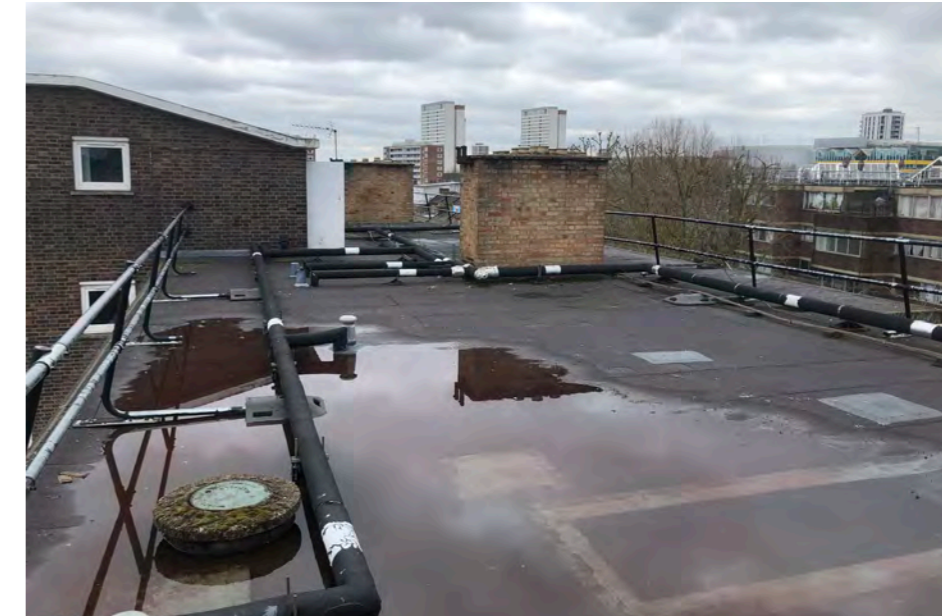
Figure 34 - Gas pipes running across rooftop
