# Henry Dickens Court Estate

## Windows/Door – Low Level Blocks

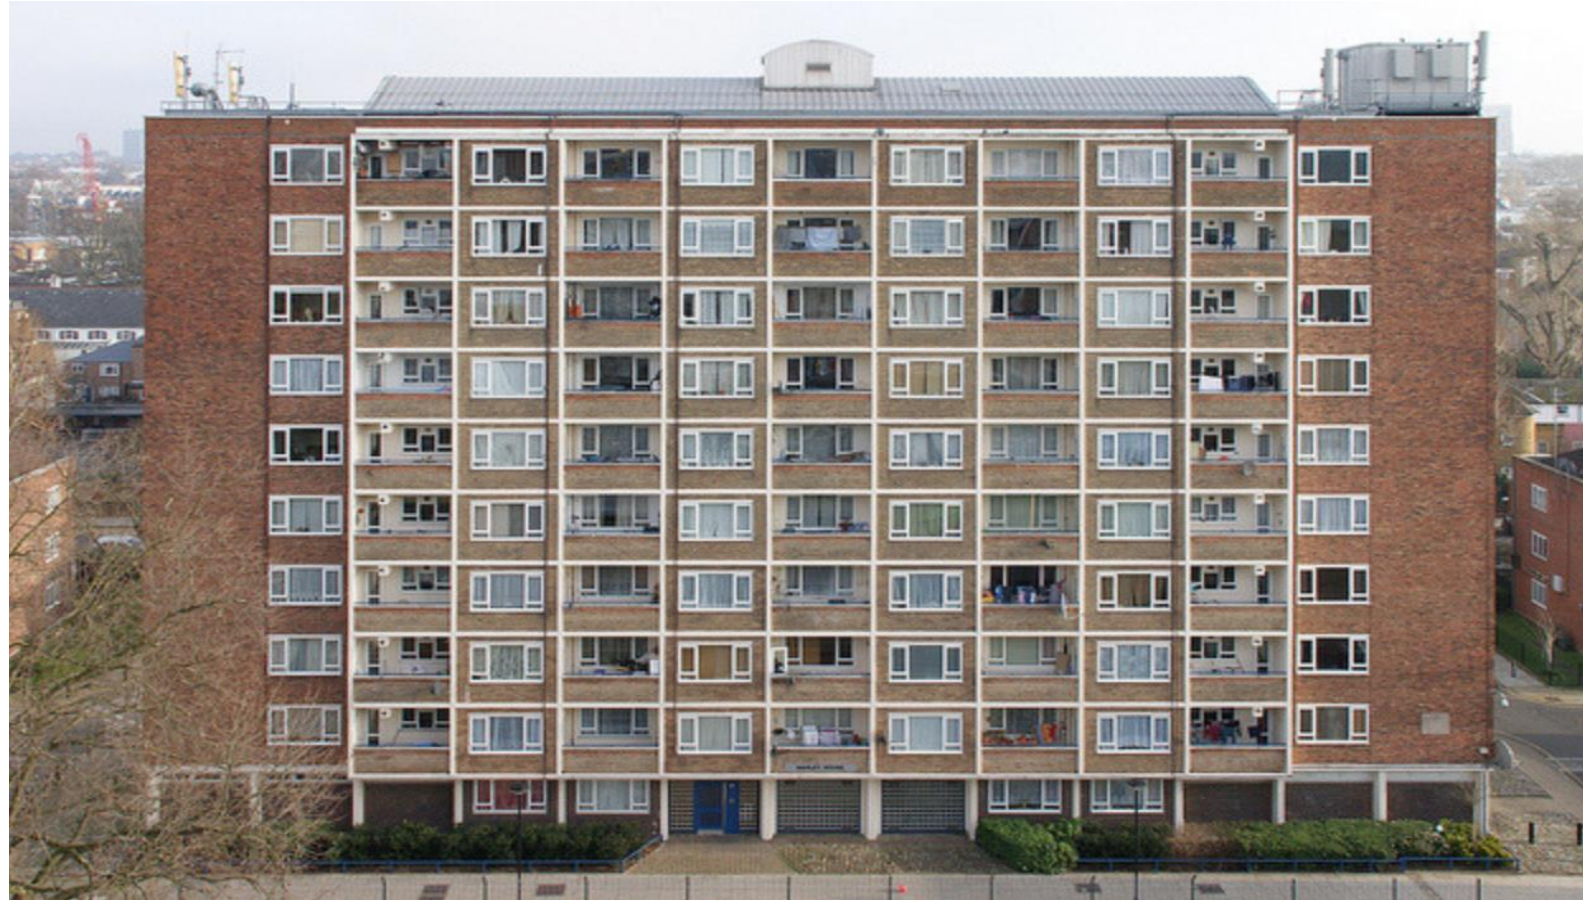
# Marley House & Carton House

1. Currently – Double Glazed uPVC
2. Proposed – Repair
3. Condition – 7/10 year life expectancy
4. Proposed consultation with all residents of both blocks to bring forward replacement
5. Whole life cost analysis undertaken Repair v Replacement
