**Fire Engineering Analysis Report**  
**TRG-220089-RT-01-FE-104**

**Project**  
**Lancaster West Sitewide**  
**Fire Service Access and Facilities**

**Date of Issue**  
**24-Jan-23**

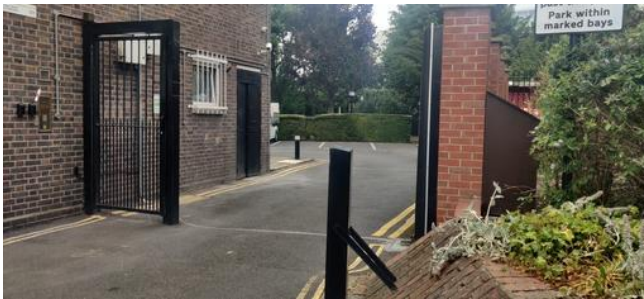
20220628\_112542\_photo

3.1m wide.

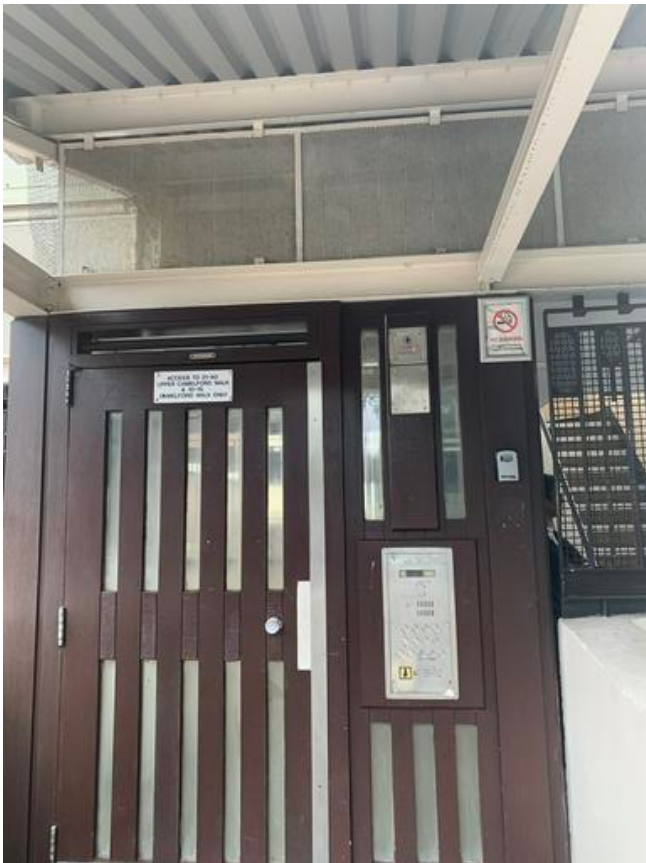
20220628\_113318\_photo

**Description**  
Fire Control Switch
